TRANSMITTAL OF THE TOP 20 ENVIRONMENTAL RESTORATION FACT SHEETS -
TGH-339-95

Enclosed are the fact sheets developed for the top 20 Environmental Restoration (ER) sites identified during the ER Prioritization effort. Also enclosed is a cover letter to transmit these fact sheets to the Environmental Protection Agency and the Colorado Department of Public Health and Environment. These fact sheets were designed to be a quick reference for each of the top 20 sites' environmental risk, probable remediation method, and any problems which may be associated with remediation.

FACT SHEET FOR TOP 20 ENVIRONMENTAL SITES
IHSS 121, 126.1, 126.2, TANK T-8

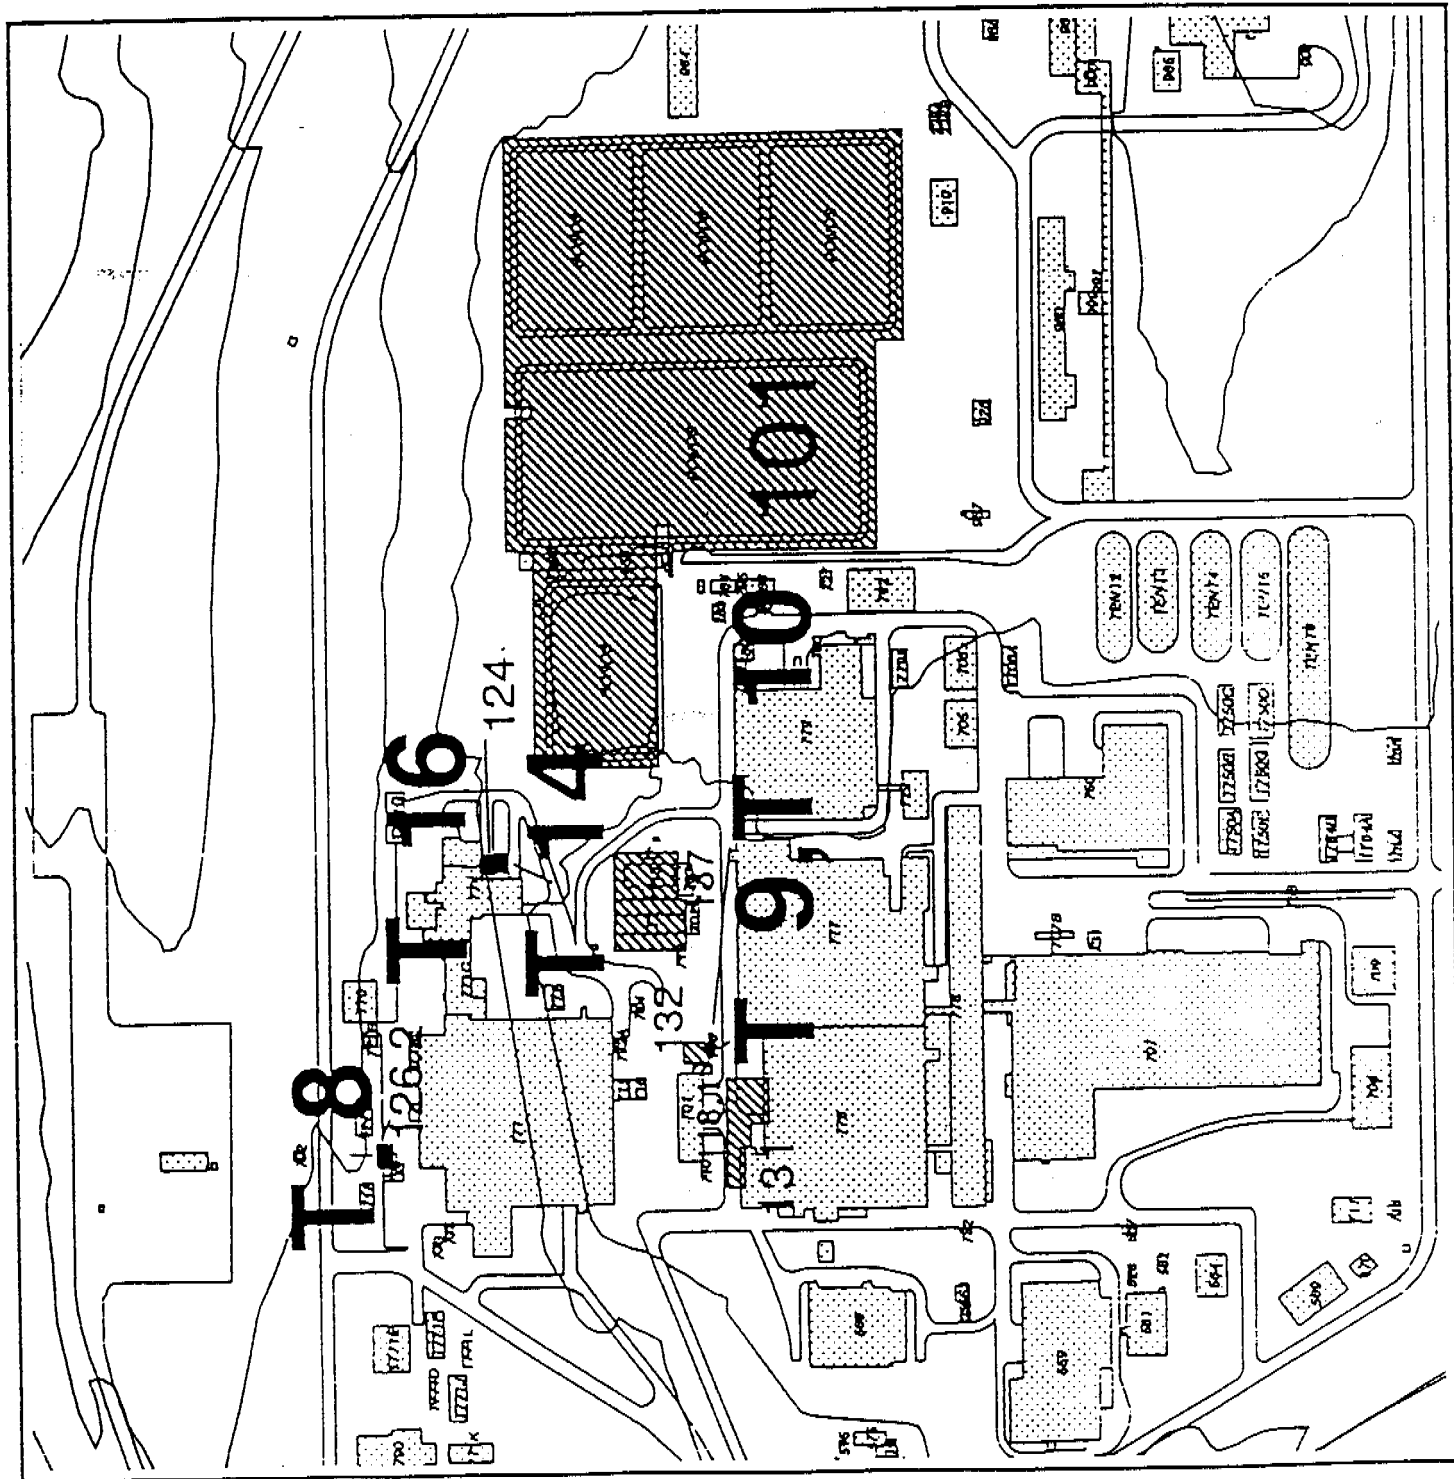
ER IHSS Ranking

- 1 - 121/124 Tank T-14
- 2 - 118.1, 132 and 121 Tanks 9610
- 3 - 121/124.1/124.2/125 PW Tank T-16N
- 13- 131 Rad Site 11
- 15- 137 Bldg 712/713 Cooling T Blowdown
- 17- 101 Solar Ponds
- 19- 121, 126.1, 126.2, Tank T-11

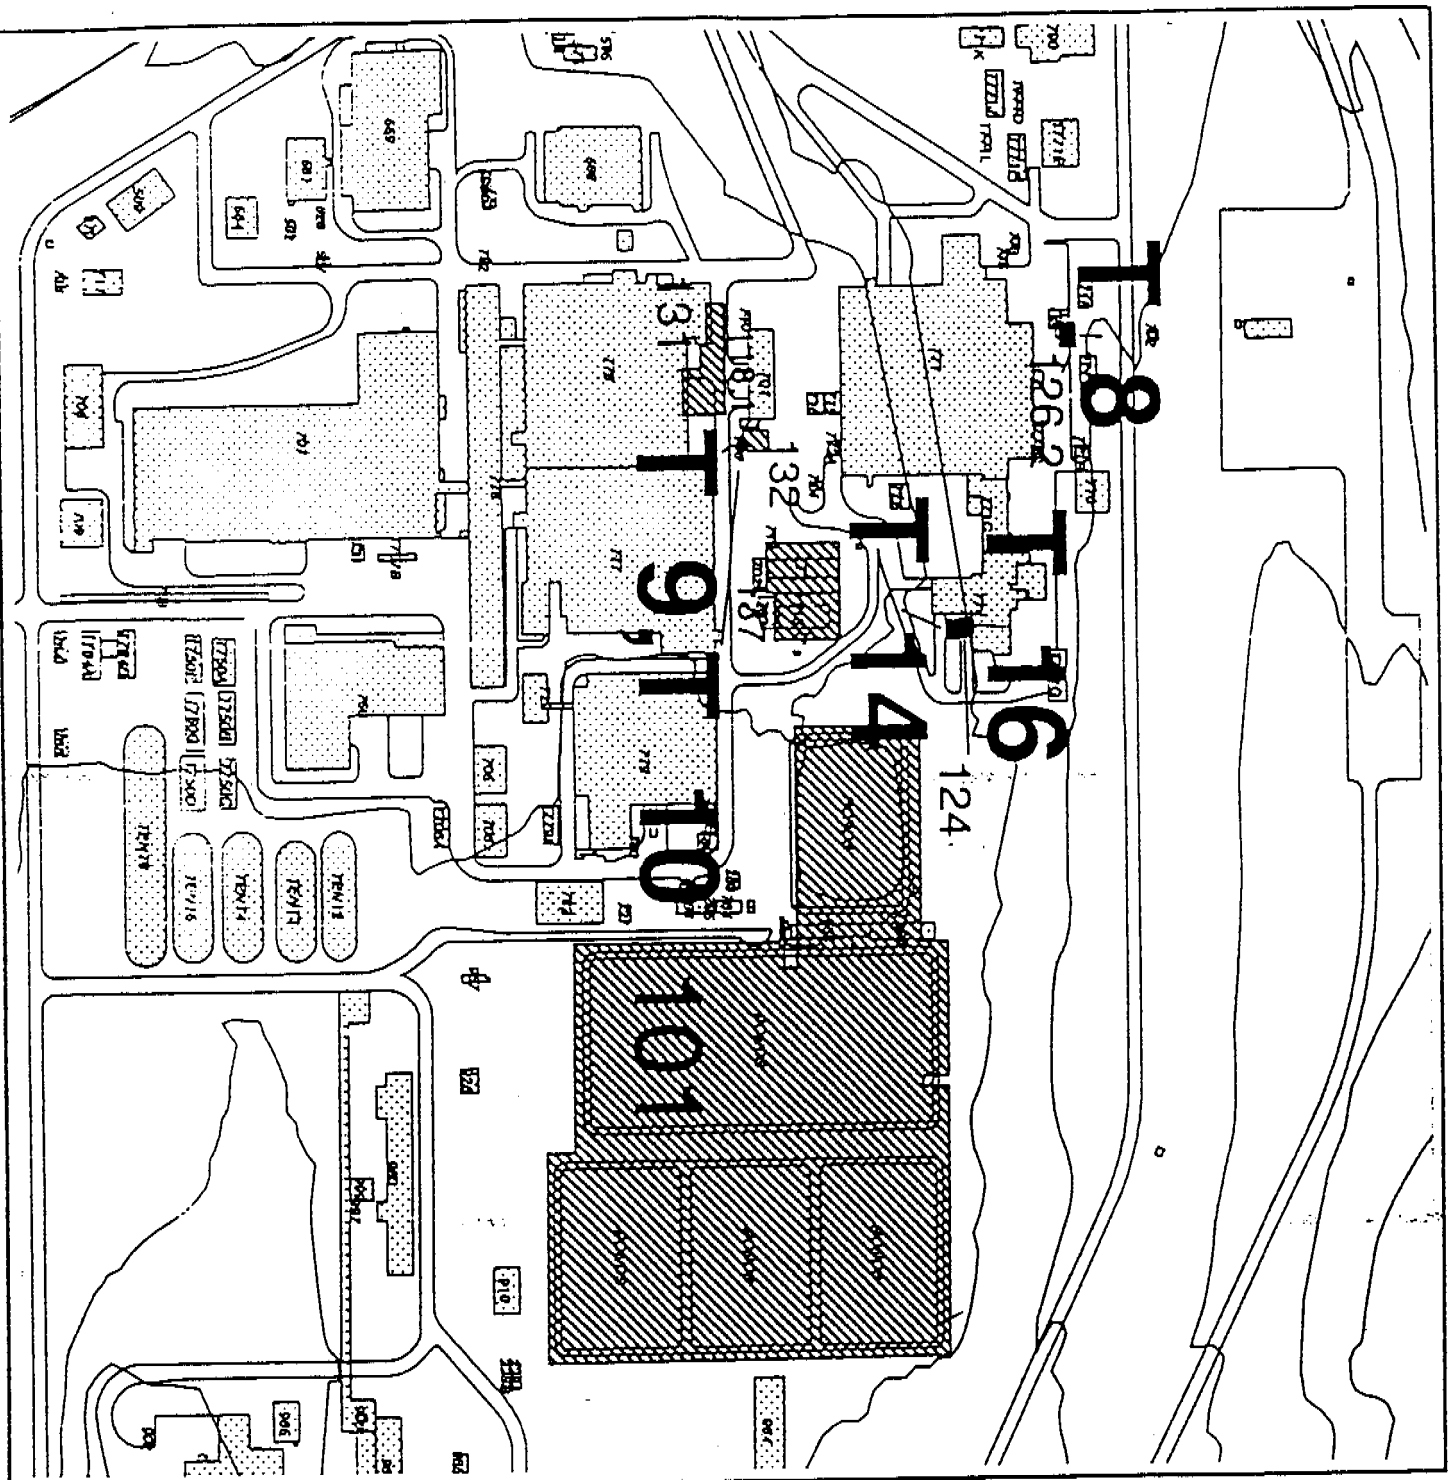
ER IHSS Ranking

■ 118.1 IHSS Locations and Labels

- 1 - 121/124 Tank T-14
- 2 - 118.1, 132 and 121 Tanks 9&10
- 3 - 121/124.1/124.2/125 PW Tank T-16N
- 13- 131 Rad Site #1
- 15- 137 Bldg 712/713
- Cooling T Blowdown
- 17- 101 Solar Ponds
- 19- 121, 126.1, 126.2, Tank T-8

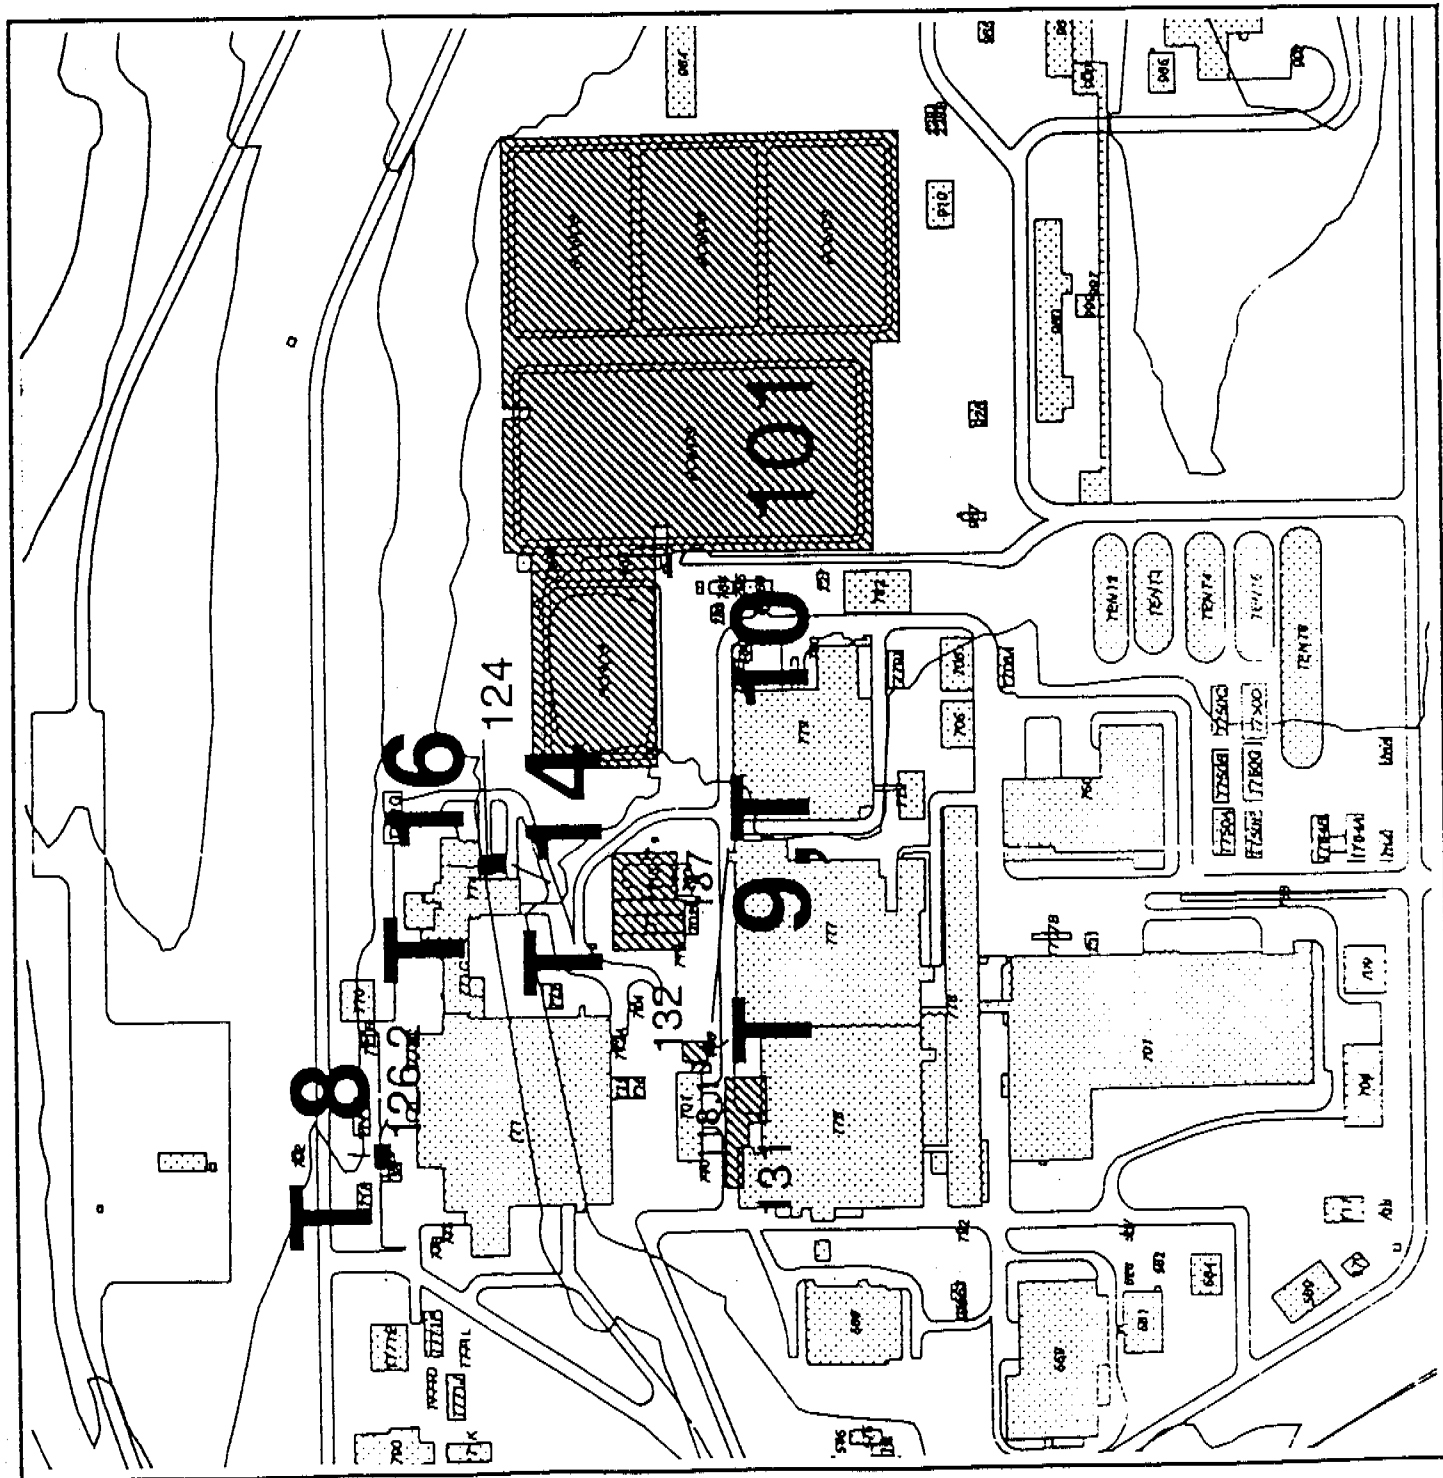
ER IHSS Ranking

- 1 - 121/124 Tank T-14
- 2 - 118.1, 132 and 121 Tanks 9&10
- 3 - 121/124.1/124.2/125 PW Tank T-16N
- 13- 131 Rad Site #1
- 15- 137 Bldg 712/713 Cooling T Blowdown
- 17- 101 Solar Ponds
- 19 121, 126.1, 126.2, Tank T-8

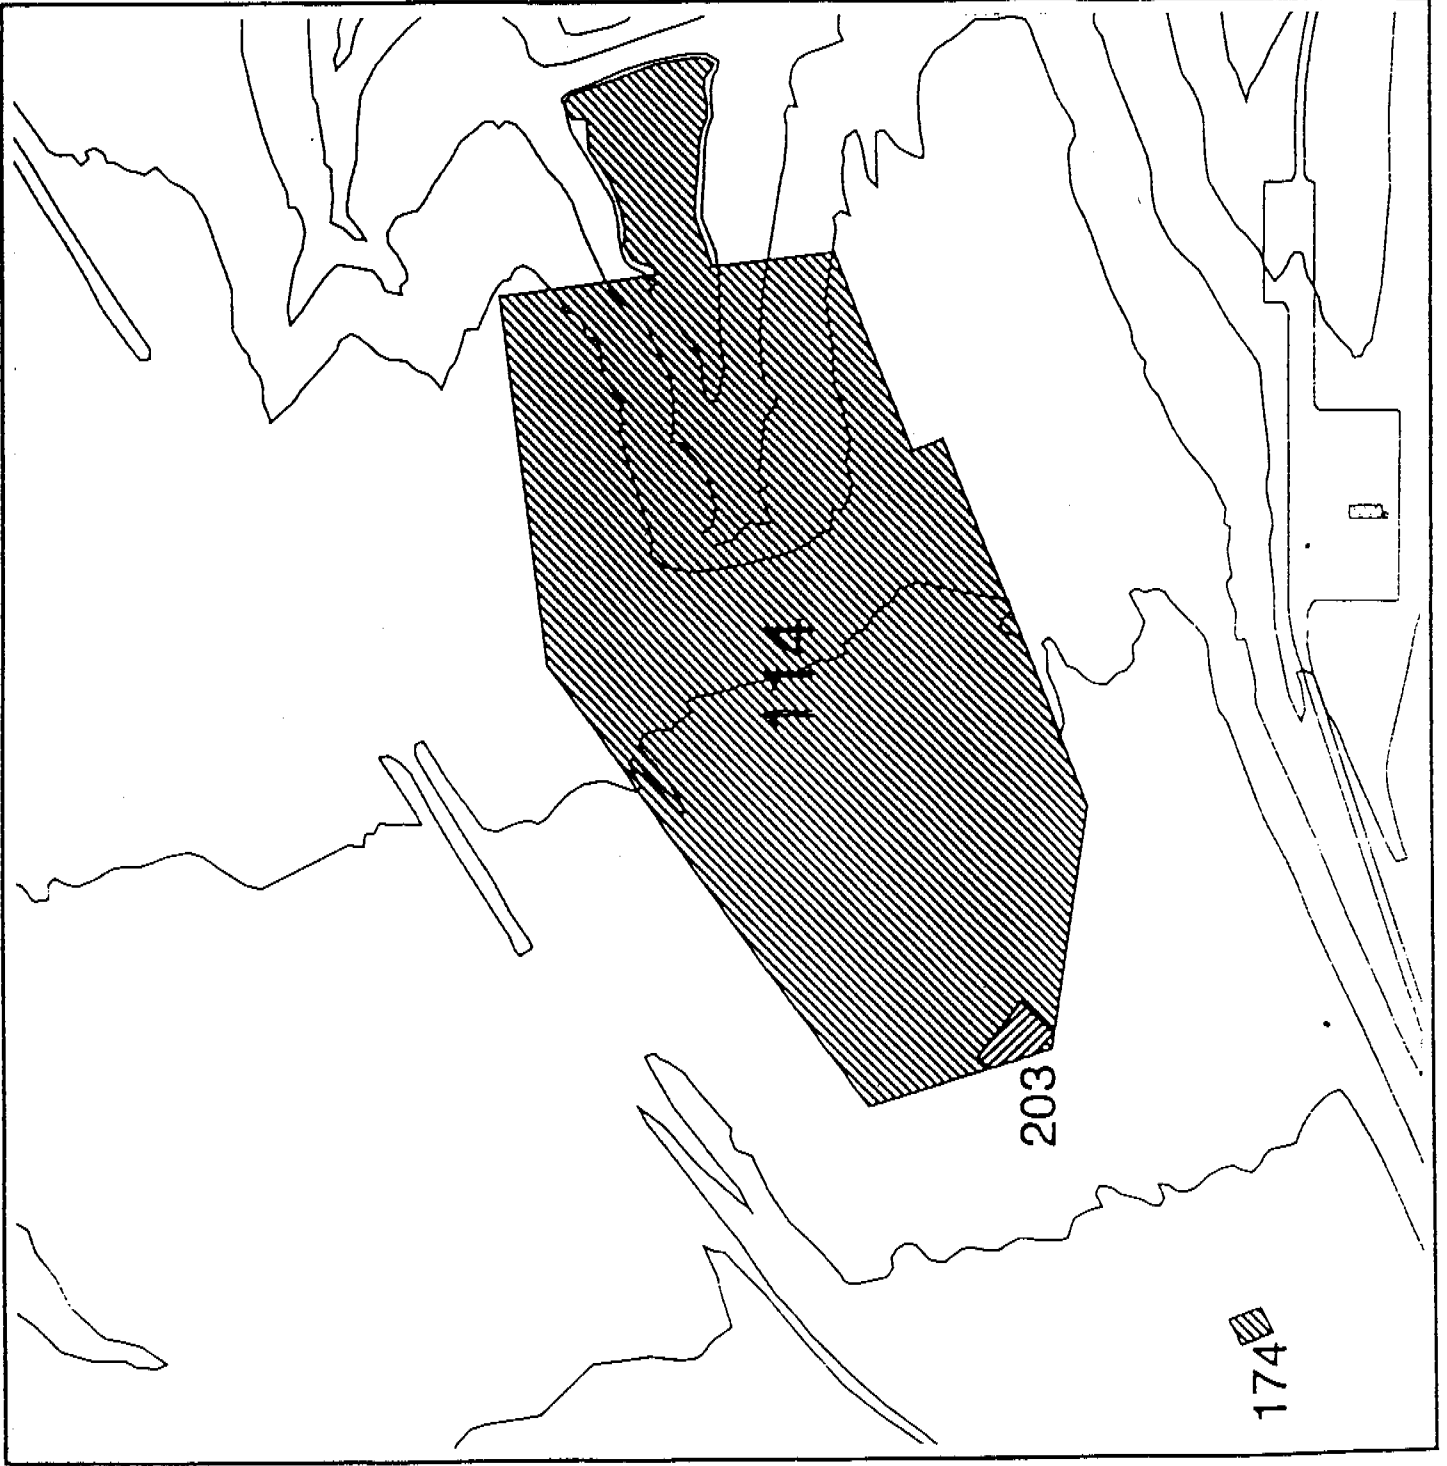
ER IHSS Ranking

16- 174.1 (174a) PU&D
Storage Areas
18- 114-Present Landfill
(includes IHSS 203)

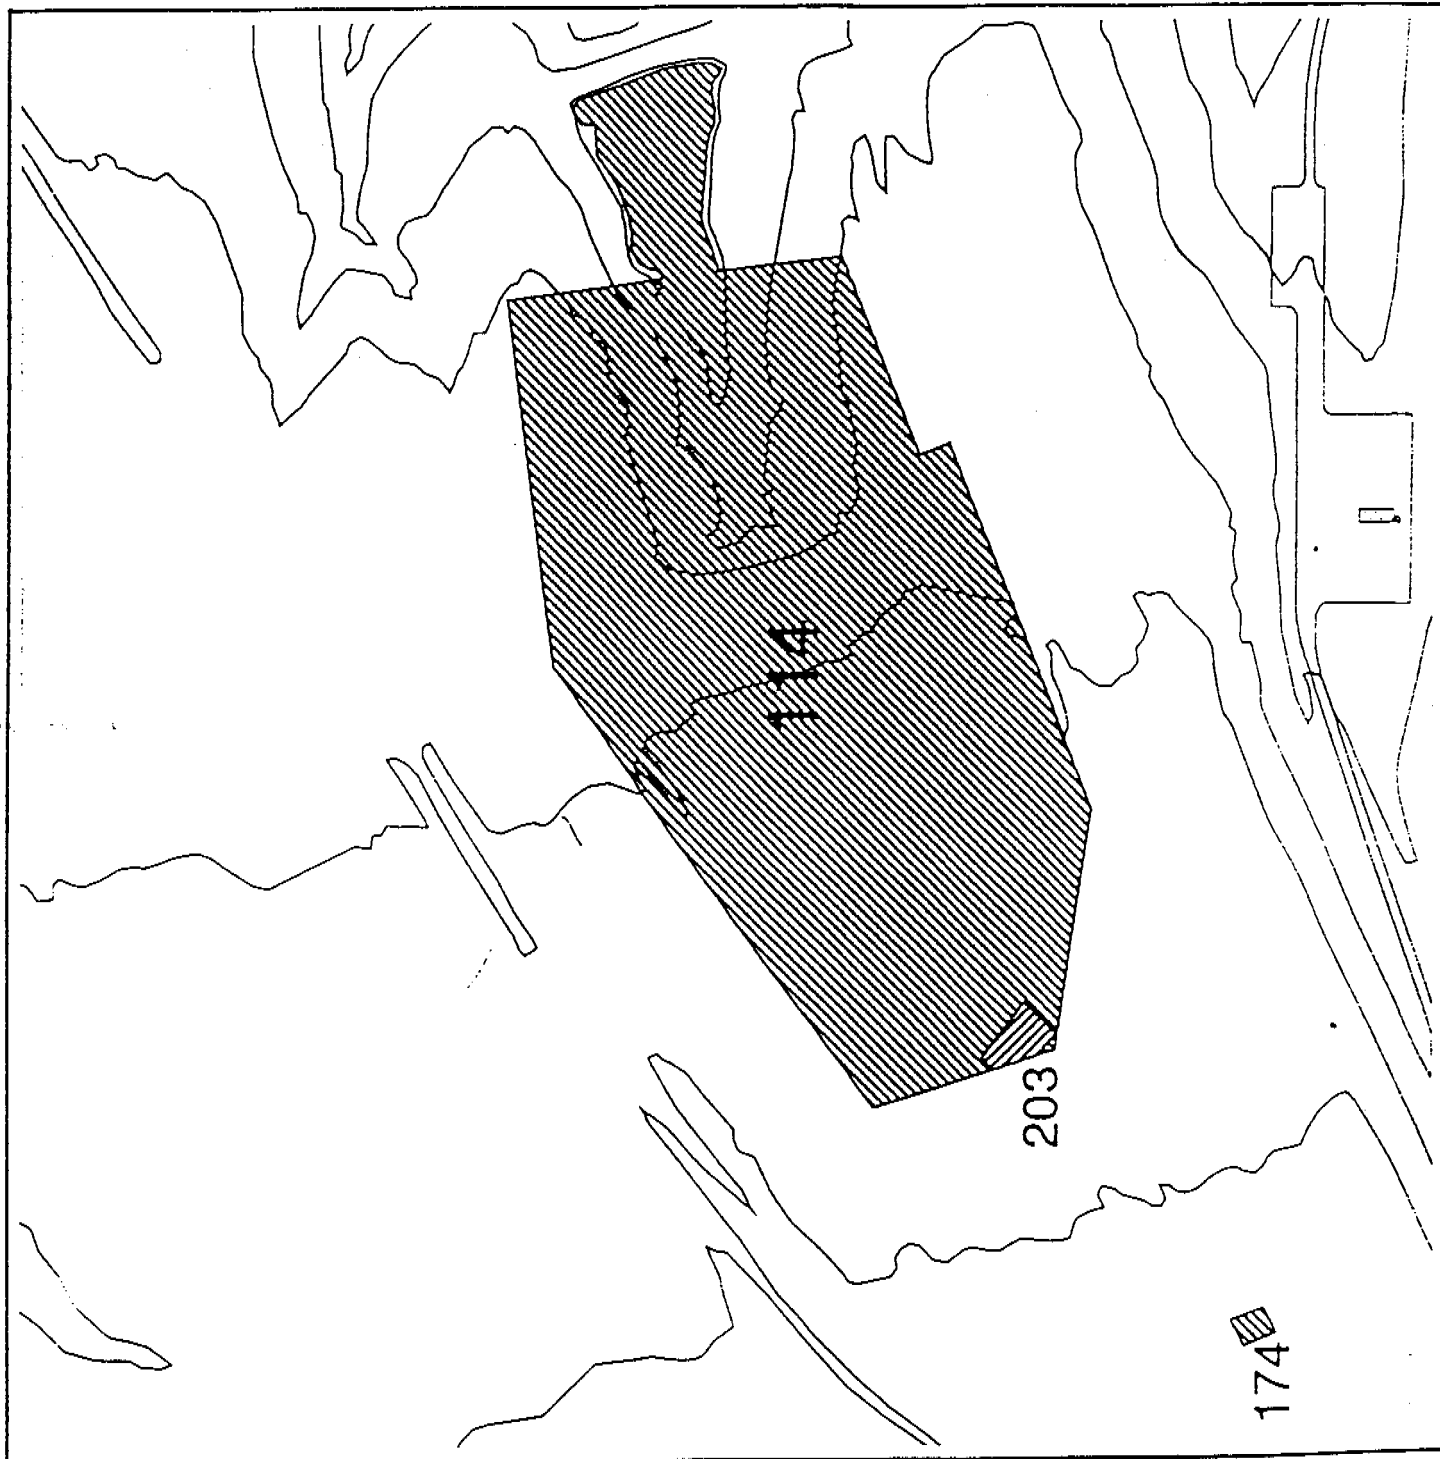
Storage Areas

18- 114-Present Landfill
(includes IHSS 203)

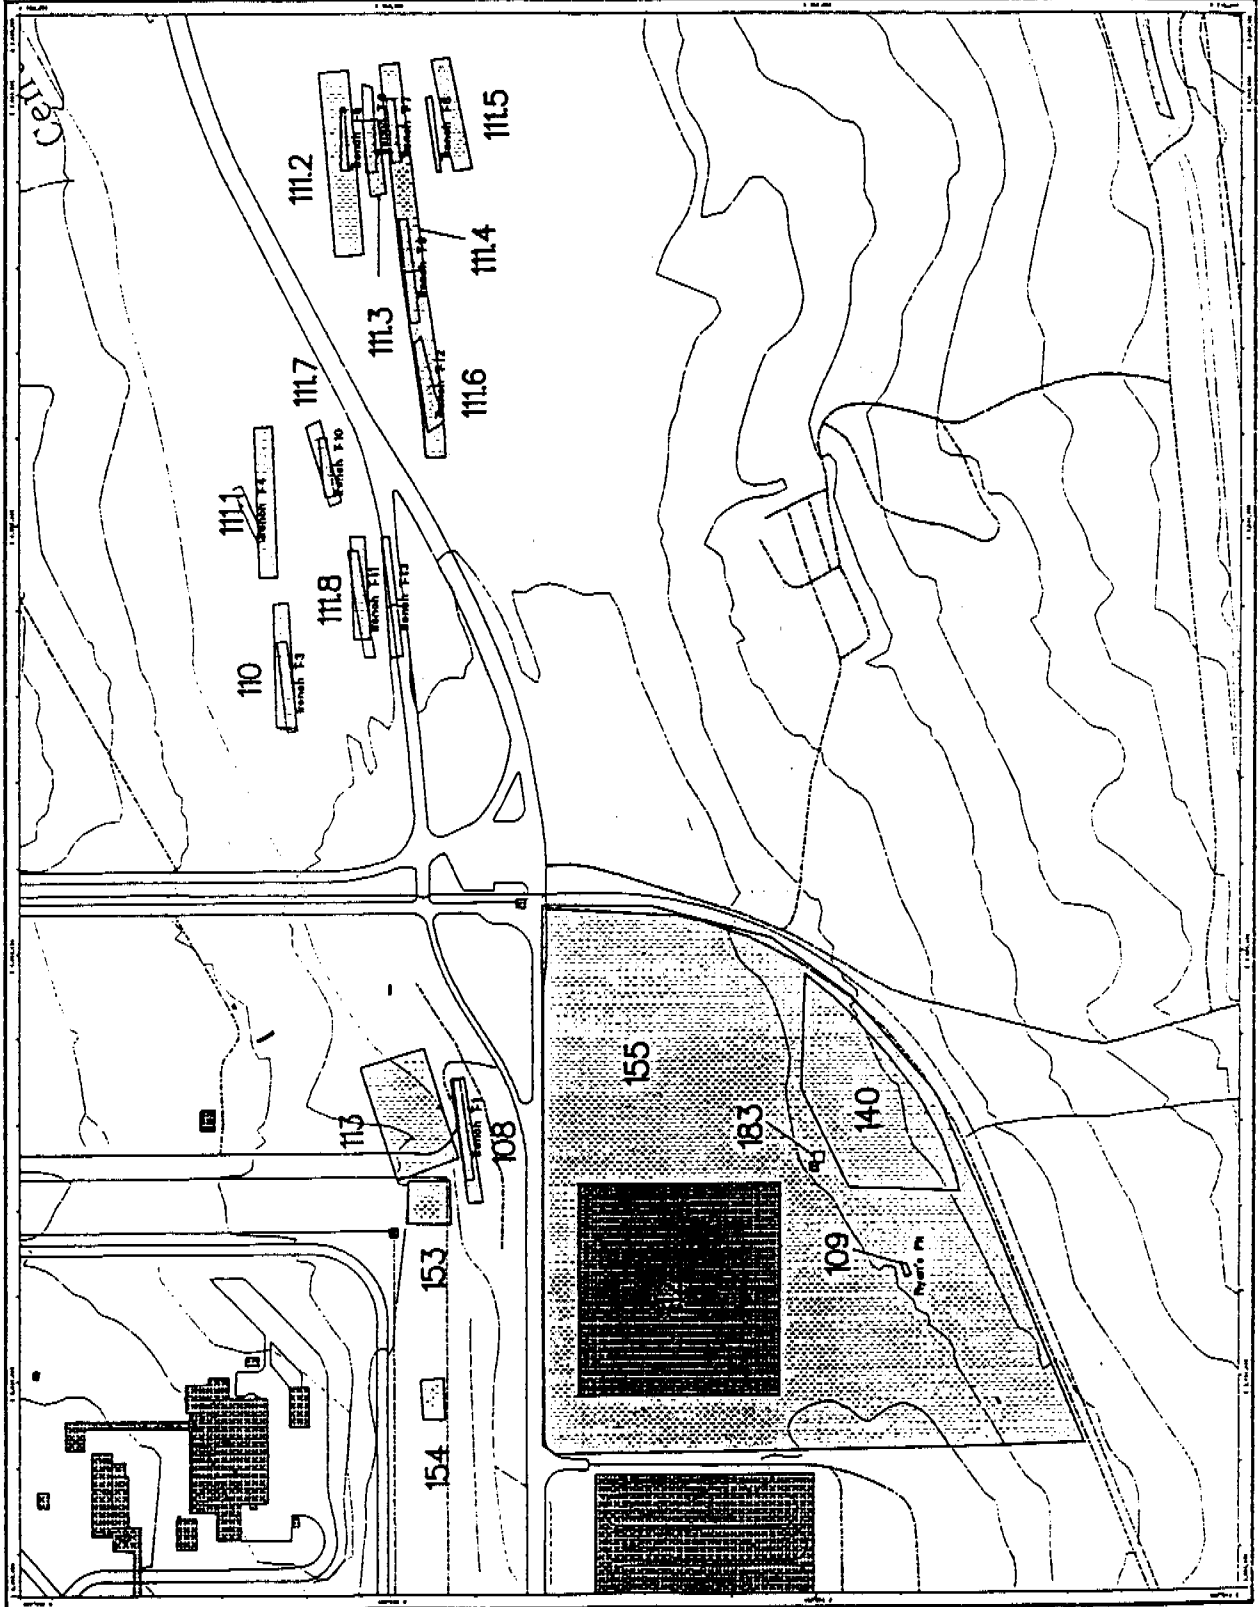
Rocky Flats
 Environmental Technology Site
 Operable Unit 2
 Map of the Site

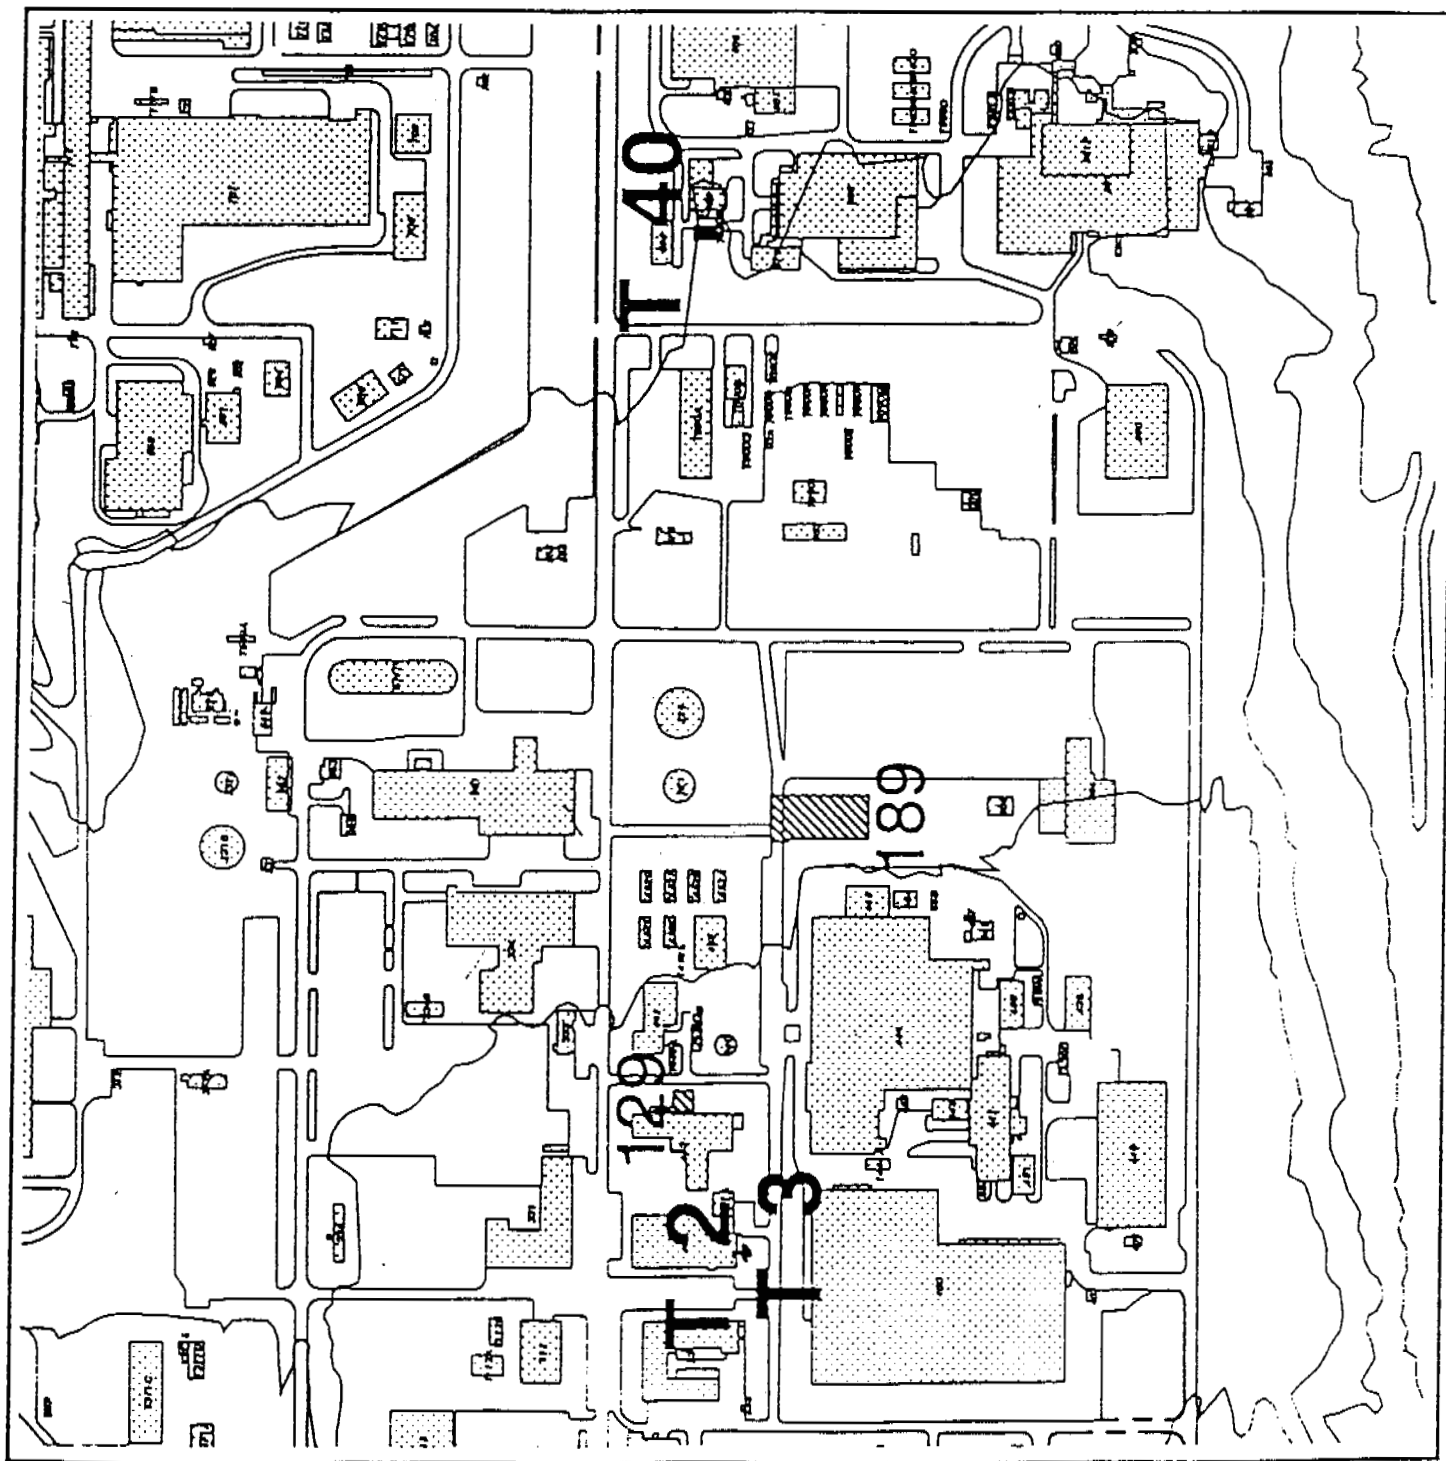
ER IHSS Ranking

5 - 121 Tanks T-2/T-3
11- 129, 2 tanks outside steam plant
14- 189 Nitric Acid Tanks
20- Tank T-40

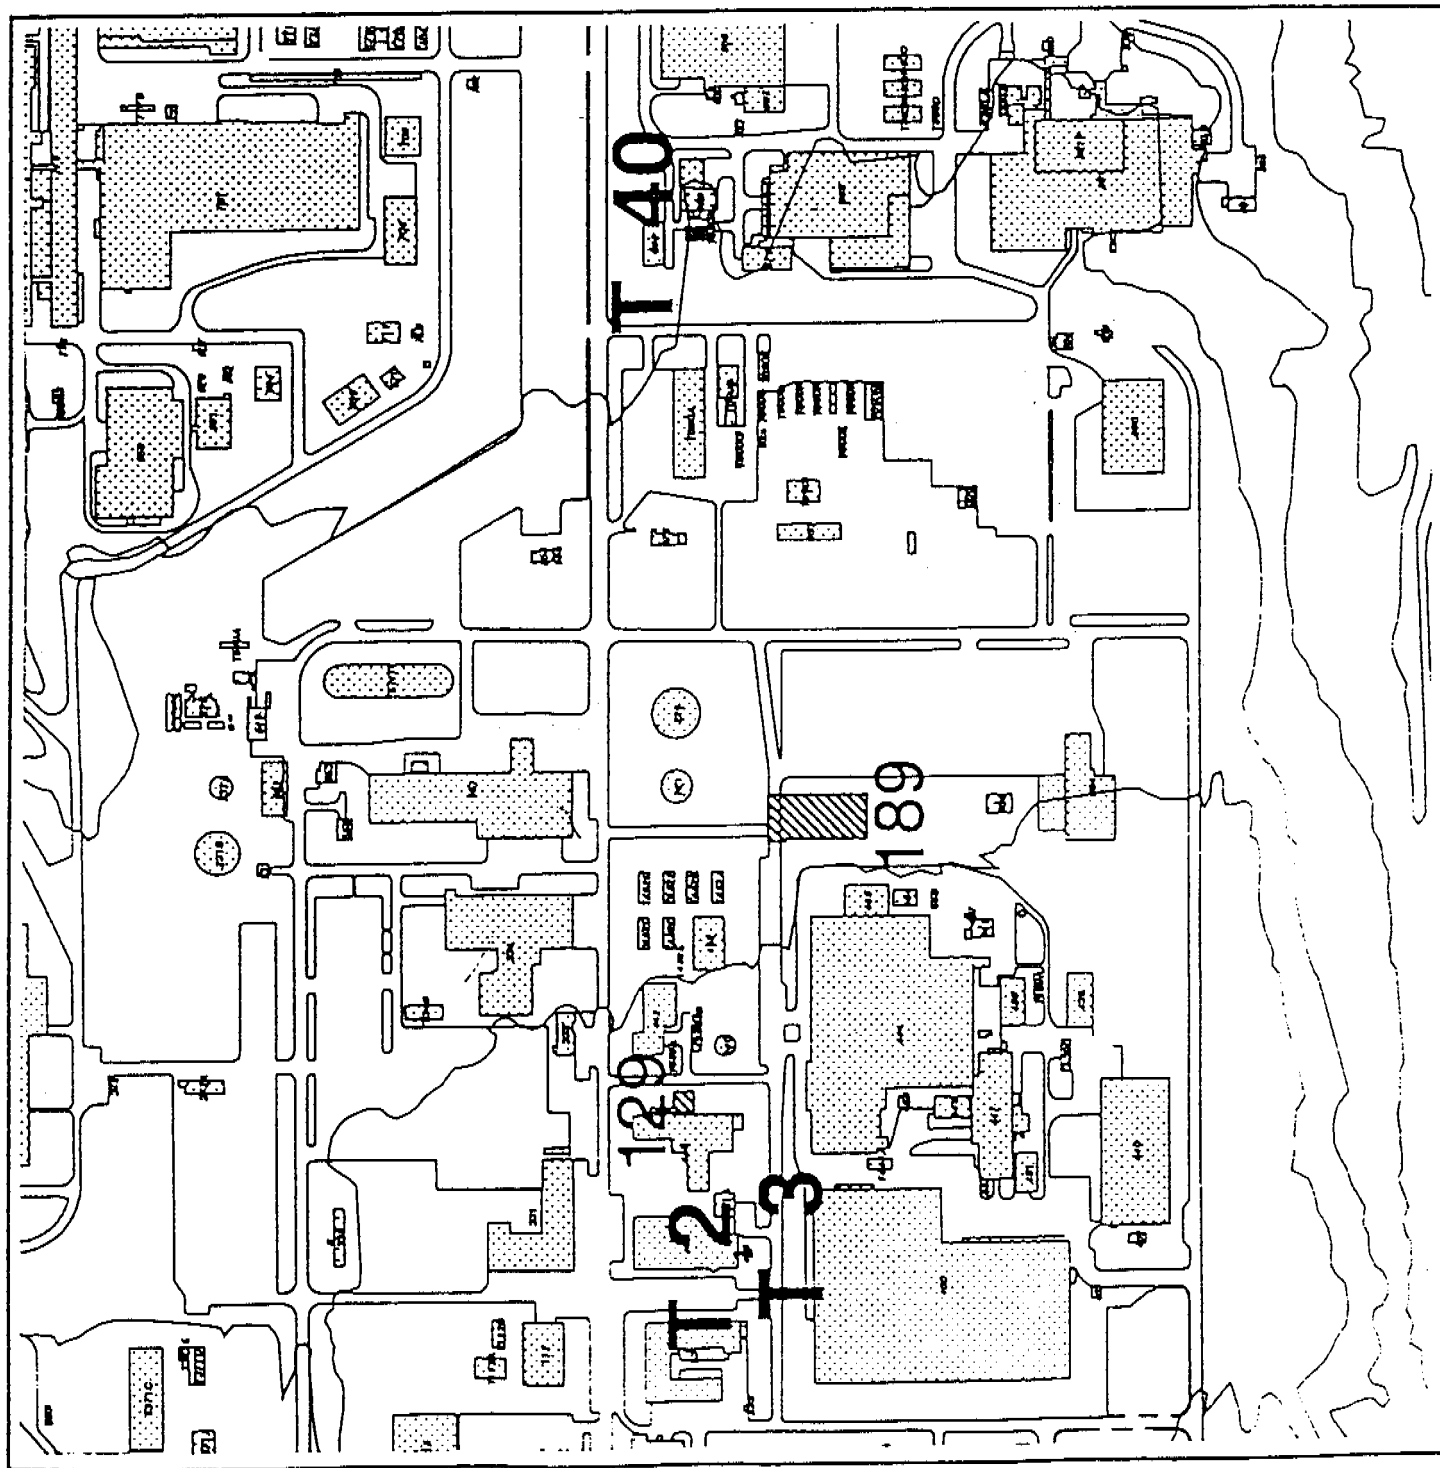
ER IHSS Ranking

- 5 - 121 Tanks T-2/T-3
- 11 - 129, 2 tanks outside steam plant
- 14 - 189 Nitric Acid Tanks
- 20 - Tank T-40

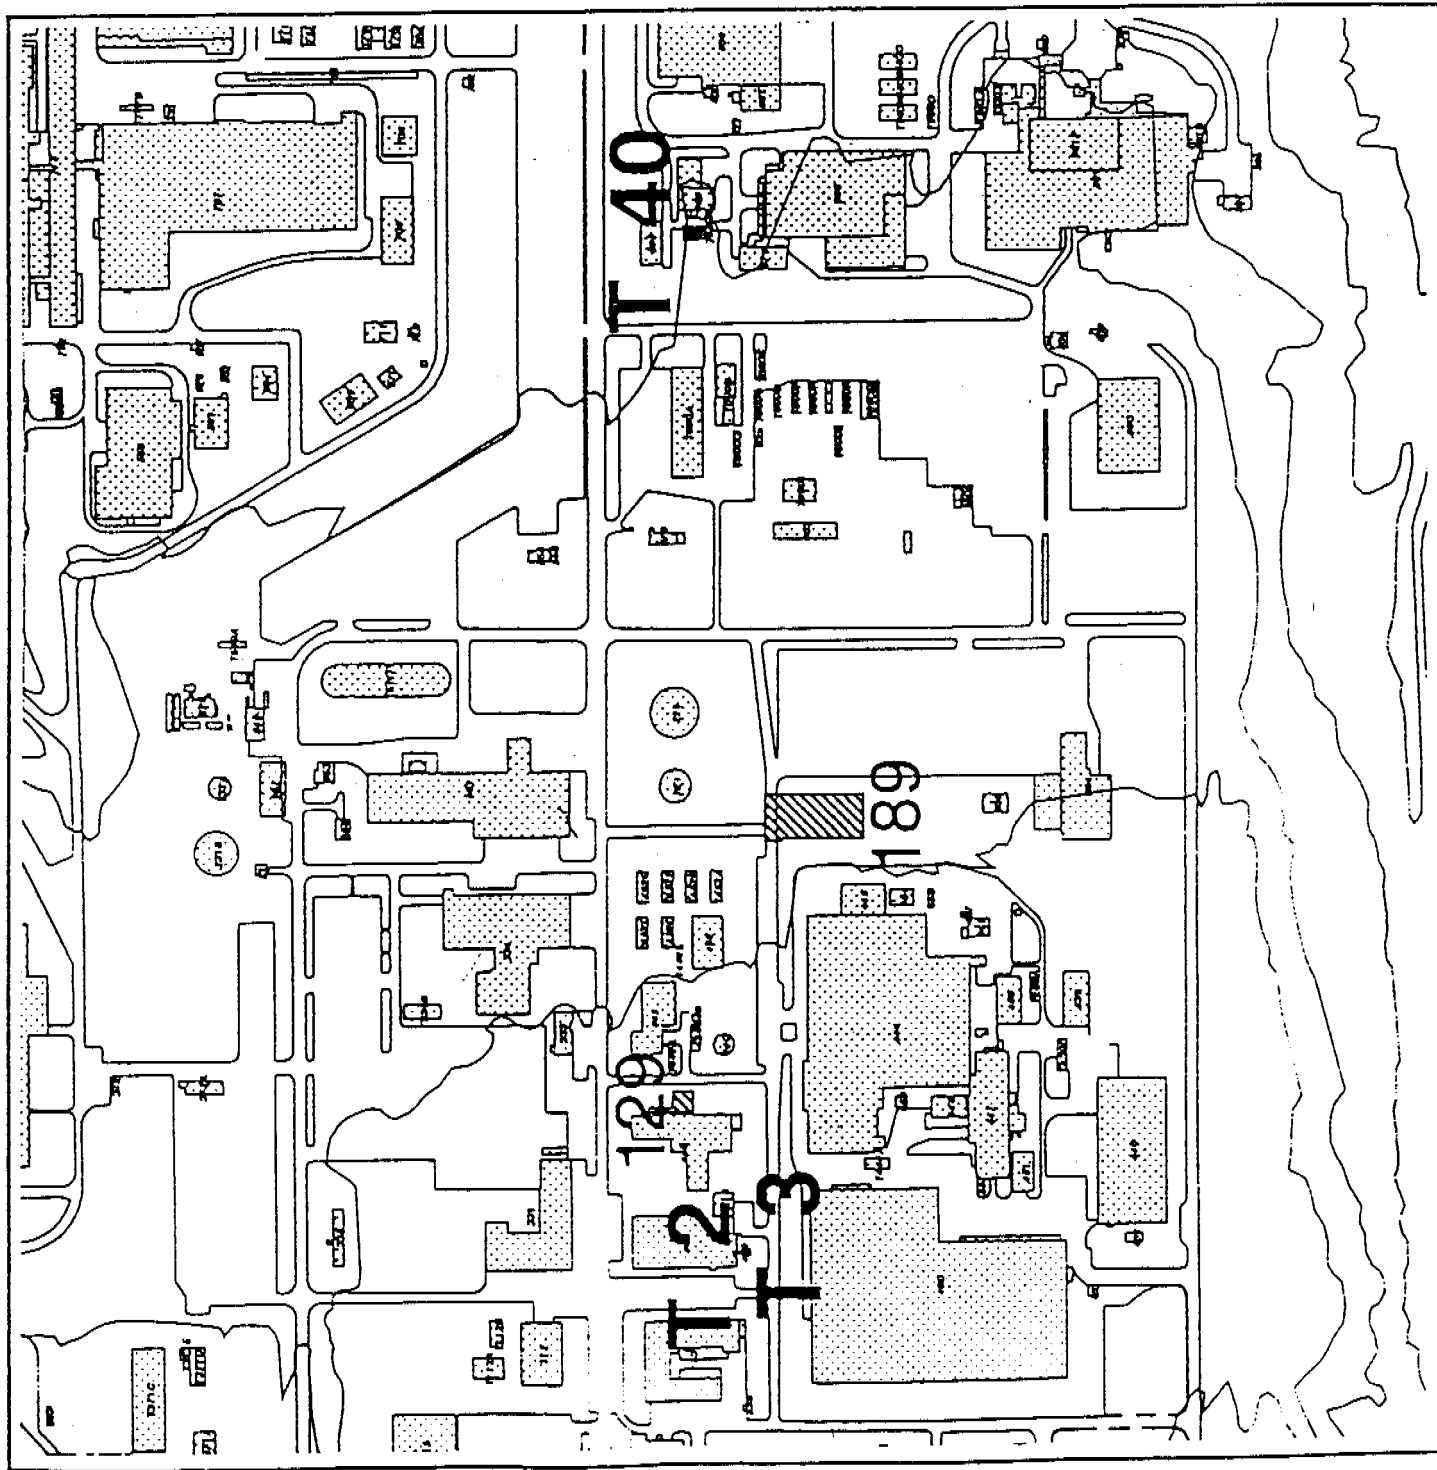
ER IHSS Ranking

- 5 - 121 Tanks T-2/T-3
- 11- 129, 2 tanks outside
steam plant
- 14- 189 Nitric Acid Tanks
- 20- Tank T-40

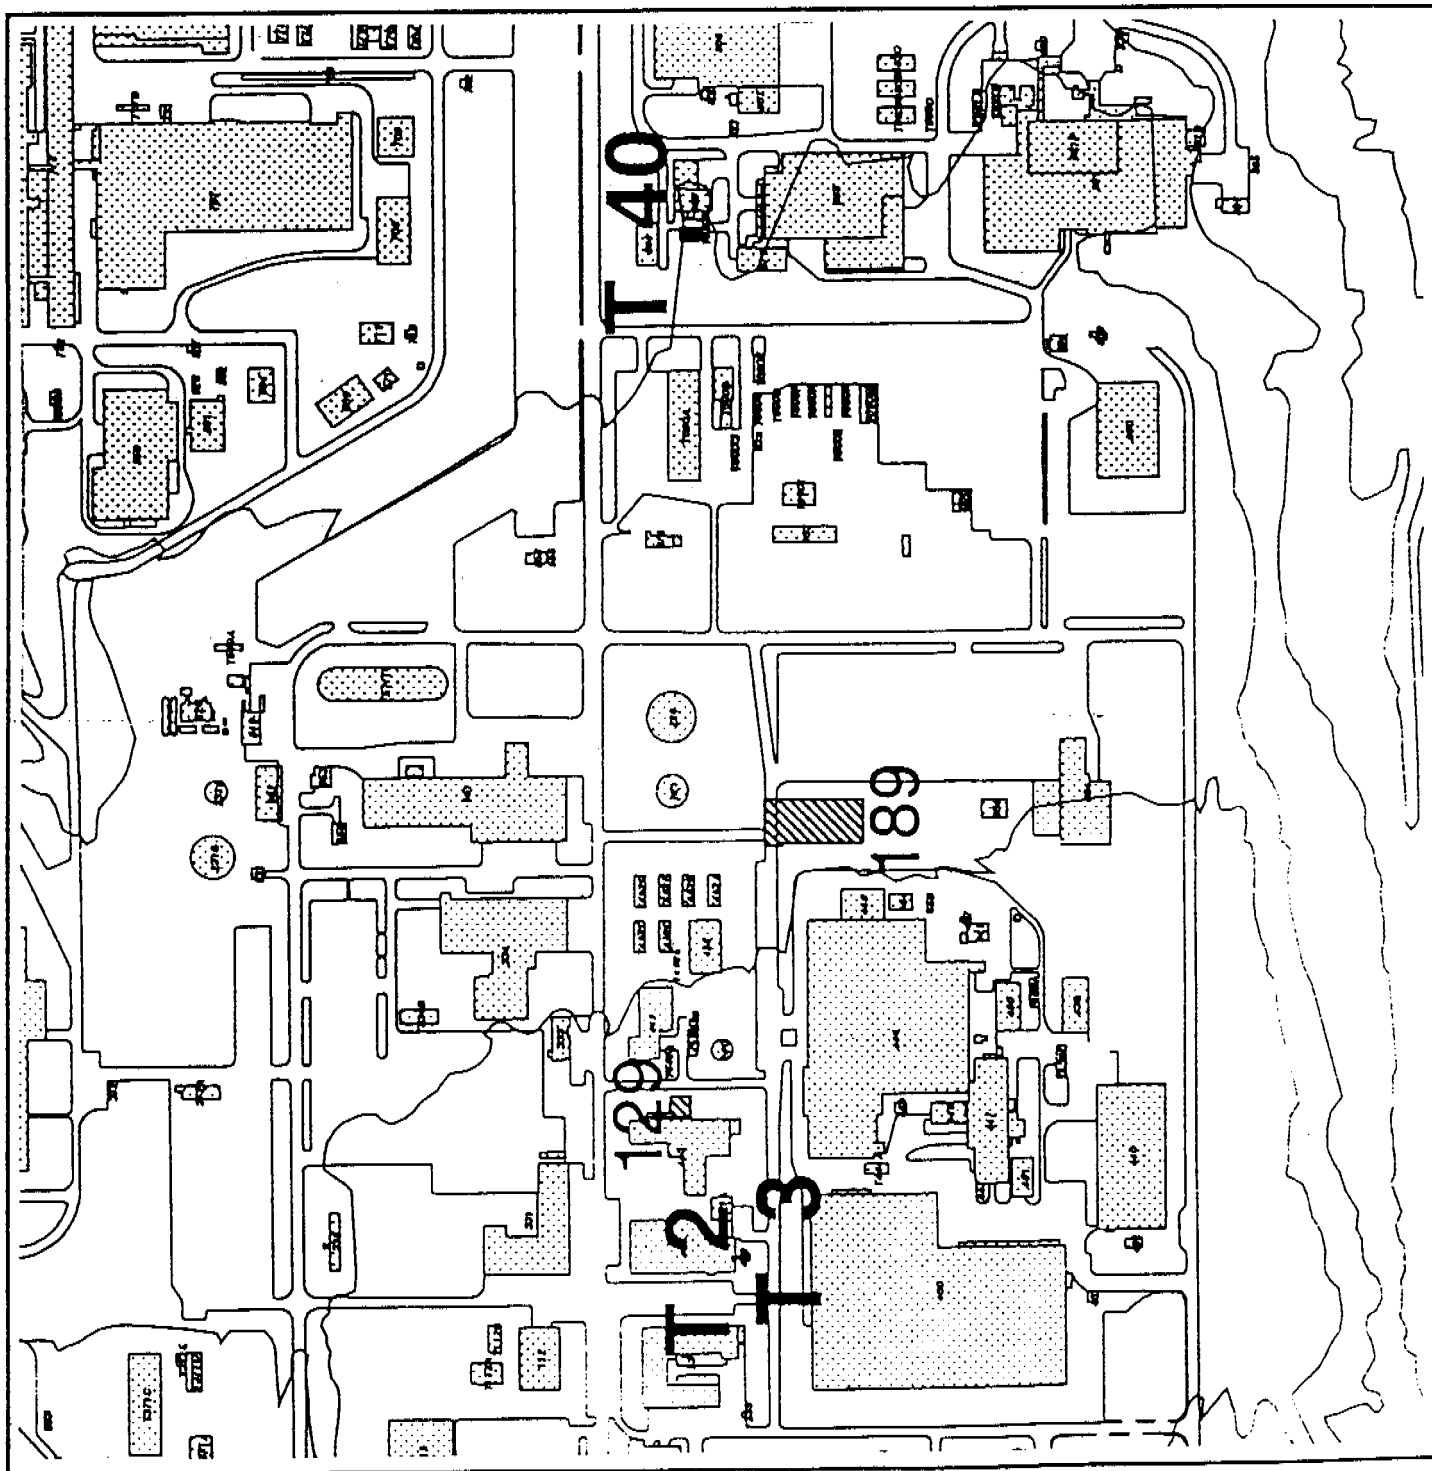
ER IHSS Ranking

- 5 - 121 Tanks T-2/T-3
- 11- 129, 2 tanks outside steam plant
- 14- 189 Nitric Acid Tanks
- 20- Tank T-40
